**Flood Control Project Maintenance
Levee Inspections**

Fall 2015 Levee Maintenance Deficiency Summary Report

Sacramento River Basin

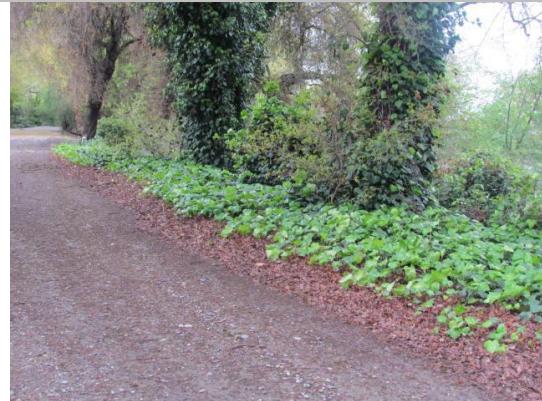
Photo 2 of 2 : FA_2015_RD0999_236_43_20150914_00045.jpg

Looking northeast at dense groundcover and vegetation on waterside slope.

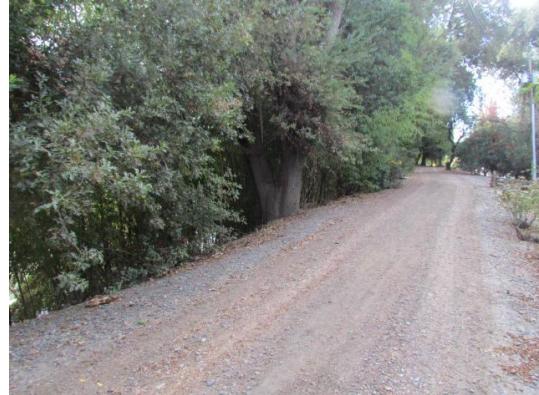
Photo 1 of 1 : FA_2015_RD0999_236_67_20150914_00062.jpg

Looking north at dense vegetation on landward shoulder and slope.

LM Start	5.47	Rating **	U	Issue No.	67										
LM End	5.52	Issue Type +	Ma	Location *	WS										
Category	Earthen Levee			GPS Latitude/Longitude											
				Start	End										
Item	Trim / Thin Trees			38.382454 °	38.383141 °										
				-121.546579 °	-121.546870 °										
DWR ID	DWR_RD0999_05_s_2012_67														
Action/Comments															
Trim trees to at least five feet above ground level.

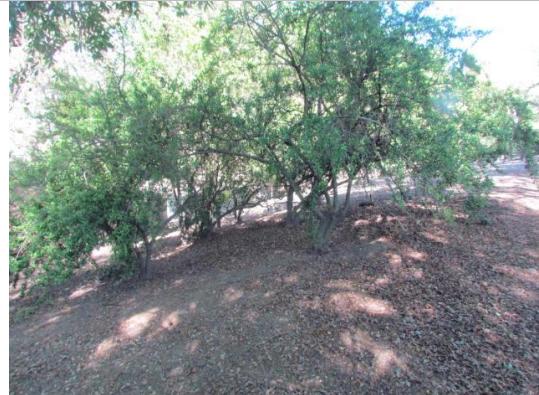
Photo 1 of 1 : FA_2015_RD0999_236_68_20150914_00063.jpg

Looking northeast at untrimmed trees on landward slope. (Spring 2015)

LM Start	5.48	Rating **	M	Issue No.	68										
LM End	5.48	Issue Type +	Ma	Location *	LS										
Category	Earthen Levee			GPS Latitude/Longitude											
				Start	End										
Item	Trim / Thin Trees			38.382553 °	38.382553 °										
				-121.546651 °	-121.546651 °										
DWR ID	DWR_RD0999_05_s_2012_68														
Action/Comments															
Trim trees to at least five feet above ground level.

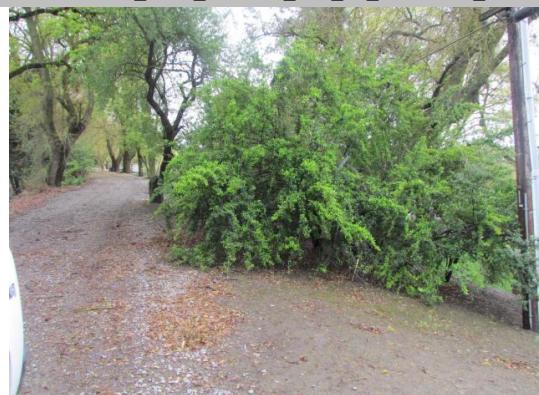
Photo 1 of 1 : FA_2015_RD0999_236_70_20150914_00064.jpg

Looking southwest at untrimmed tree on waterside shoulder and slope.

LM Start	5.49	Rating **	M	Issue No.	70										
LM End	5.49	Issue Type +	Ma	Location *	LS										
Category	Earthen Levee			GPS Latitude/Longitude											
				Start	End										
Item	Trim / Thin Trees			38.382698 °	38.382698 °										
				-121.546711 °	-121.546711 °										
DWR ID	DWR_RD0999_05_s_2012_70														
Action/Comments															
Trim and thin trees to allow visibility of the ground and room to flood fight.

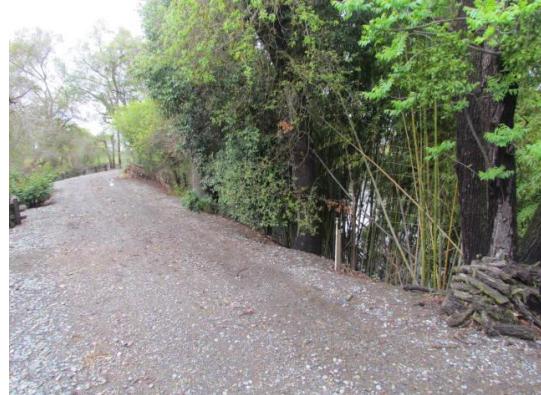
Photo 1 of 1 : FA_2015_RD0999_236_71_20150914_00065.jpg

Looking northeast at dense vegetation on waterside slope.

LM Start	5.50	Rating **	U	Issue No.	71										
LM End	5.55	Issue Type +	Ma	Location *	WS										
Category	Earthen Levee			GPS Latitude/Longitude											
				Start	End										
Item	Vegetation			38.382790 °	38.383548 °										
				-121.546754 °	-121.546728 °										
DWR ID	DWR_RD0999_05_s_2012_71														
Action/Comments															
Remove the wild growth other than native grasses from the levee slopes.

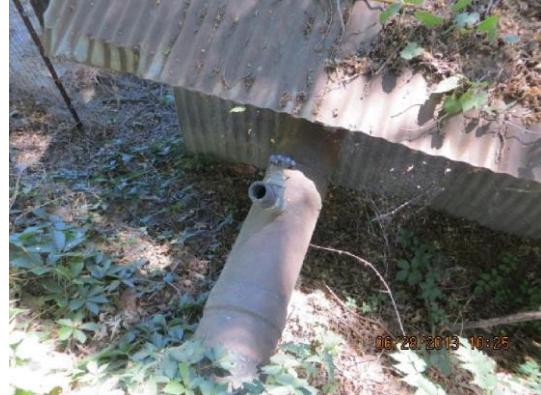
Photo 1 of 3 : UCIP_FA_2015_1296.jpg

Item	DWR UCIP Field Study			38.382821 °	38.382821 °										
				-121.546661 °	-121.546661 °										
DWR ID															
Action/Comments															
Inspector Comments: FS_ID:15446 DS_ID:22857 EP_NO: N/A FS_HLM: 5.586 Repair Type: Non-Urgent Crossing Status: Found UCIP Comments: Pipe appears abandoned and should be done so appropriately. FIELD_STRUCT_DESC: 10-inch steel irrigation pipe through the levee 4-feet below the crown. Pumphouse and gate valve on the waterward slope. Vent on LS slope and a 42-inch concrete standpipe on LS toe. service pole on the landward slope with a 1.5-inch galvanized iron electrical conduit at same location. Originally included in the 1966 O&M manual. FS Date: 06/28/2013

Vent on pipe at WS shoulder.

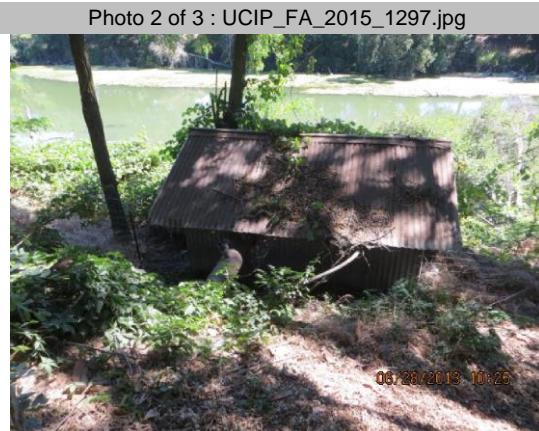
Corrugated metal pumphouse on WS slope.

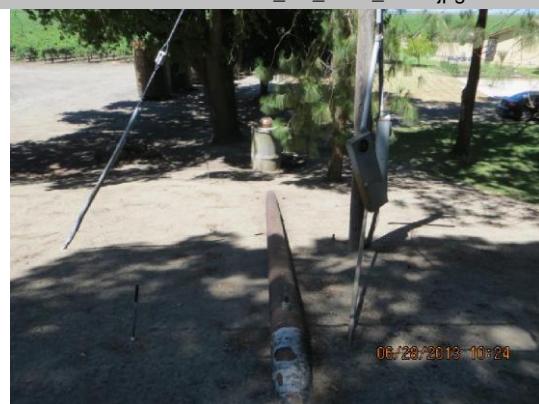
Pipe visible on LS slope with JP, Meter and electrical conduit, and concrete standpipe,

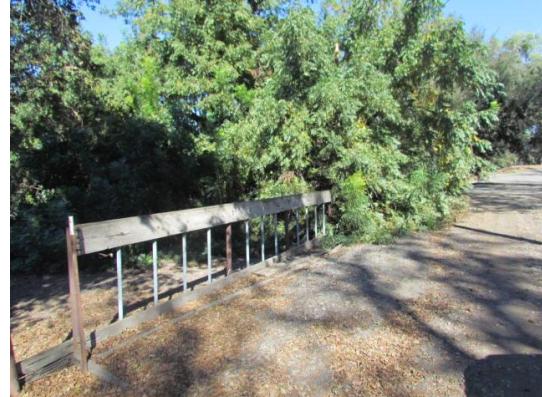
Photo 1 of 1 : FA_2015_RD0999_236_203_20151106_00165.jpg

Looking at untrimmed trees on landward slope and toe.

LM Start	5.56	Rating **	U	Issue No.	203												
LM End	5.61	Issue Type +	Ma	Location *	LS												
Category	Earthen Levee			GPS Latitude/Longitude													
				Start	End												
Item	Trim / Thin Trees			38.383740 °	38.384218 °												
				-121.546628 °	-121.546095 °												
DWR ID	DWR_RD0999_05_f_2014_203																
Action/Comments																	
Trim trees to at least five feet above ground level.

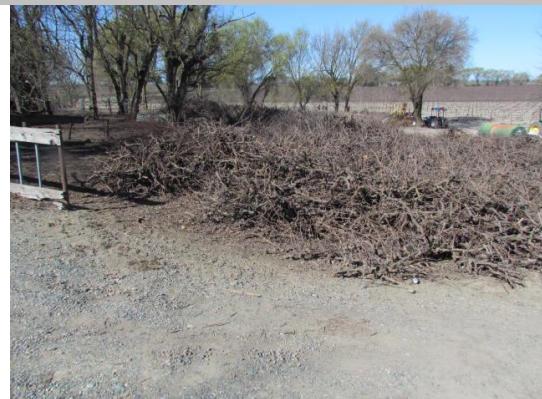
Photo 1 of 1 : FA_2015_RD0999_236_192_20150914_00117.jpg

LM Start	5.58	Rating **	A/W	Issue No.	192												
LM End	5.58	Issue Type +	Ma	Location *	LS												
Category	Earthen Levee			GPS Latitude/Longitude													
				Start	End												
Item	Encroachments			38.383978 °	38.383978 °												
				-121.546435 °	-121.546435 °												
DWR ID	DWR_RD0999_05_s_2014_192																
Action/Comments																	
Prunings Inspector Comments: Landowner pile prunings on landside slope.

Looking west at prunings on landward slope and toe.

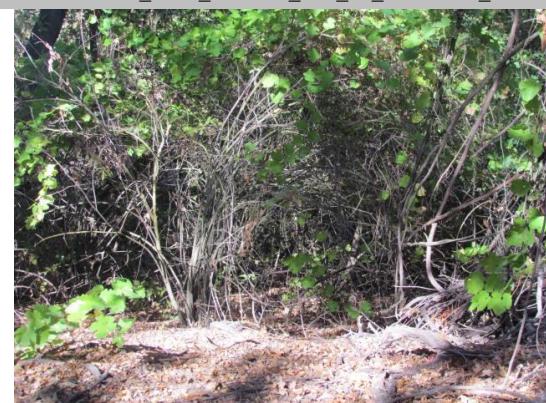
Looking west at dense vegetation on landward slope and toe. Fall 2015

LM Start	5.80	Rating **	U	Issue No.	48		Photo 1 of 2 : FA_2015_RD0999_236_48_20151106_00166.jpg															
LM End	5.84	Issue Type +	Ma	Location *	LS																	
Category	Earthen Levee			GPS Latitude/Longitude																		
				Start	End																	
Item	Vegetation			38.384718 °	38.384930 °																	
				-121.542590 °	-121.541883 °																	
DWR ID	DWR_RD0999_05_s_2012_48																					
Action/Comments																						
Remove the wild growth other than native grasses from the levee slopes.

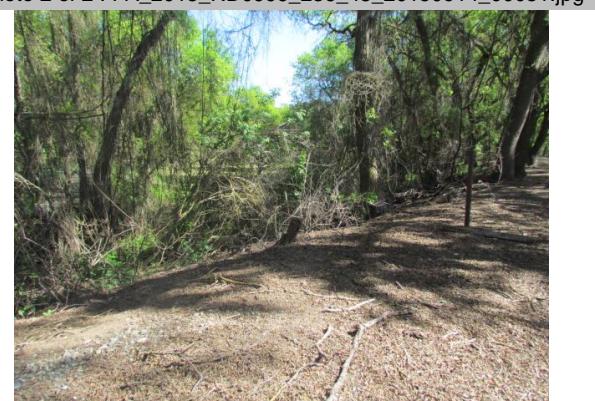
LM Start	5.80	Rating **	U	Issue No.	48 (cont)	
LM End	5.84	Issue Type +	Ma	Location *	LS

Looking east at dense vegetation on landward slope. (Spring 2015)

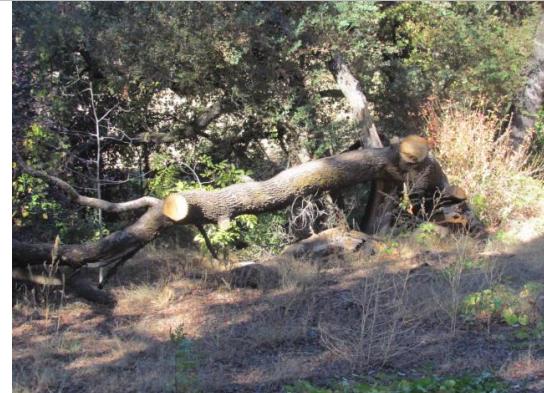
Photo 1 of 2 : FA_2015_RD0999_236_39_20151106_00167.jpg

LM Start	5.93	Rating **	U	Issue No.	39																	
LM End	5.93	Issue Type +	Ma	Location *	LS																	
Category	Earthen Levee				GPS Latitude/Longitude																	
					Start	End																
Item	Encroachments				38.385729 °	38.385729 °																
					-121.540863 °	-121.540863 °																
DWR ID	DWR_RD0999_05_s_2013_39																					
Action/Comments																						
Tree or limb Inspector Comments: Large downed trees and vegetation blocking landward toe.

Looking west at fallen tree and dense vegetation blocking landward toe.
Fall 2015.

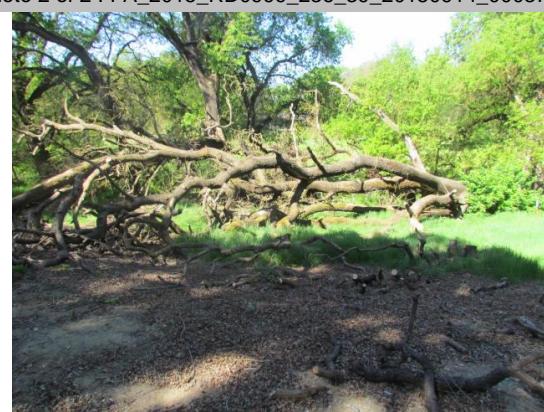
Photo 2 of 2 : FA_2015_RD0999_236_39_20150914_00037.jpg

Looking west at fallen tree on landward slope and toe. (Spring 2015)

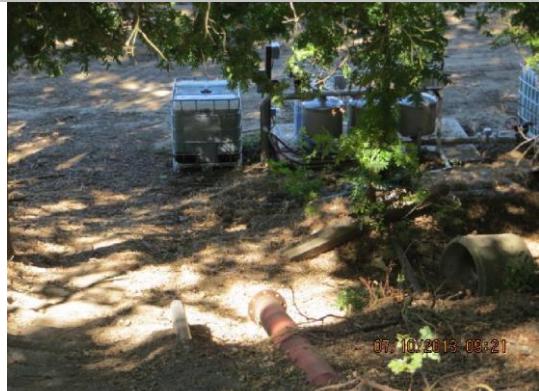
Photo 1 of 3 : UCIP_FA_2015_1377.jpg

LM Start	6.13	Rating **	M	Issue No.	225													
LM End	6.13	Issue Type +	En	Location *	LS													
Category	Supplemental			GPS Latitude/Longitude														
				Start	End													
Item	DWR UCIP Field Study			38.388151 °	38.388151 °													
				-121.542624 °	-121.542624 °													
DWR ID																		
Action/Comments																		
Inspector Comments: FS_ID:40791 DS_ID:22890 EP_NO: N/A FS_HLM: 6.226 Repair Type: Non-Urgent Crossing Status: Found

Pipe visible on LS slope with filter plant in background.

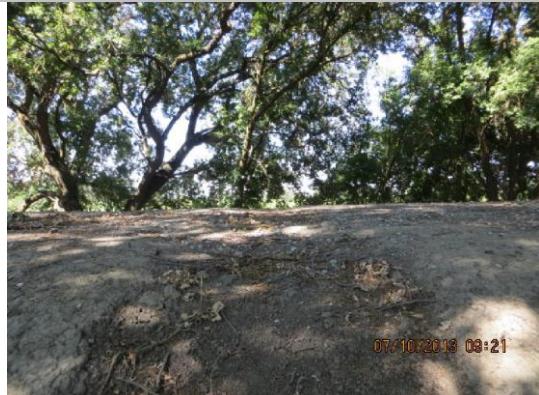
Photo 2 of 3 : UCIP_FA_2015_1378.jpg

Settlement along pipe alignment on crown.

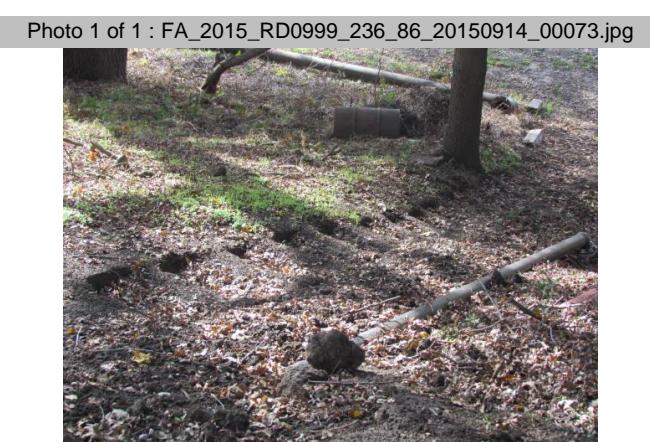
LM Start	6.13	Rating **	M	Issue No.	86													
LM End	6.13	Issue Type +	En	Location *	LS													
Category	Earthen Levee			GPS Latitude/Longitude														
				Start	End													
Item	Encroachments			38.388159 °	38.388159 °													
				-121.542646 °	-121.542646 °													
DWR ID	DWR_RD0999_05_f_2012_86																	
Action/Comments																		
Stairway Inspector Comments: Landowner dug stairs into landside slope.

Looking east at excavated stairs on landside slope

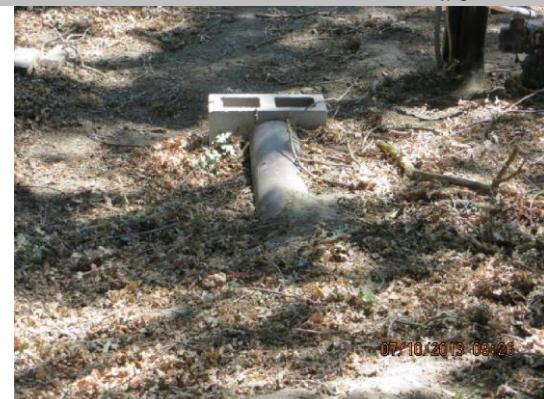
LM Start	6.13	Rating **	U	Issue No.	226 (cont)				
LM End	6.13	Issue Type +	En	Location *	LS

Pipe visible on WS slope.

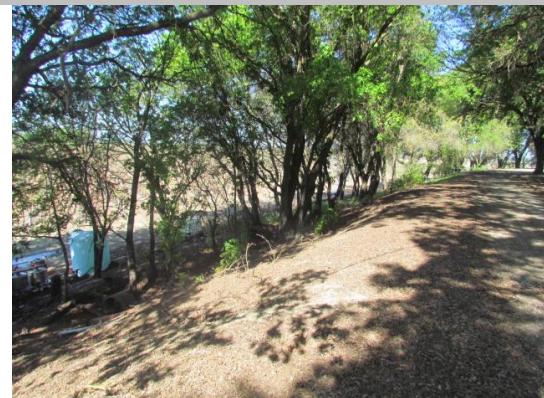
Photo 1 of 1 : FA_2015_RD0999_236_60_20150914_00058.jpg

Looking north at dense trees on landward slope. (Spring 2015)

LM Start	6.13	Rating **	M	Issue No.	60									
LM End	6.13	Issue Type +	Ma	Location *	LS									
Category	Earthen Levee			GPS Latitude/Longitude										
				Start	End									
Item	Trim / Thin Trees			38.388225 °	38.388225 °									
				-121.542697 °	-121.542697 °									
DWR ID	DWR_RD0999_05_s_2012_60													
Action/Comments														
Trim and thin trees to allow visibility of the ground and room to flood fight.

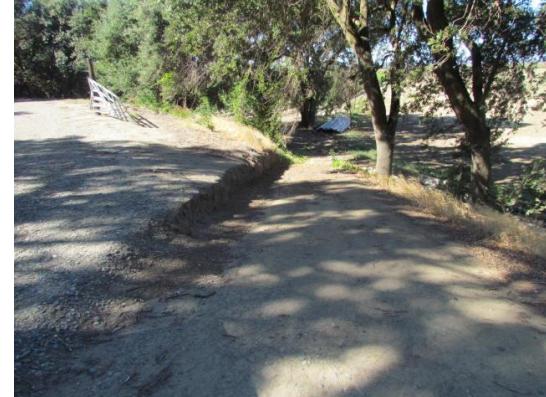
Photo 1 of 1 : FA_2015_RD0999_236_155_20150914_00106.jpg

LM Start	6.26	Rating **	M	Issue No.	155																		
LM End	6.26	Issue Type +	En	Location *	LS																		
Category	Earthen Levee			GPS Latitude/Longitude																			
				Start	End																		
Item	Encroachments			38.389946 °	38.389946 °																		
DWR ID	DWR_RD0999_05_f_2013_155																						
Action/Comments																							
Ramp Inspector Comments: Unauthorized ramp on landward slope.

Looking southwest at ramp on landward slope.

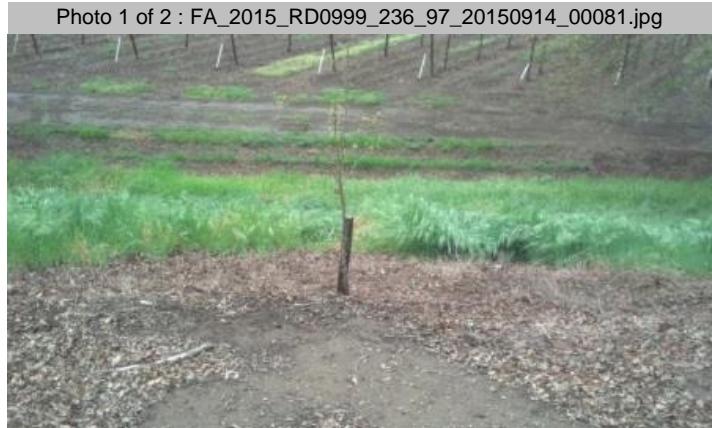
Photo 1 of 2 : FA_2015_RD0999_236_97_20150914_00081.jpg

LM Start	6.37	Rating **	M	Issue No.	97																		
LM End	6.49	Issue Type +	En	Location *	LS																		
Category	Earthen Levee			GPS Latitude/Longitude																			
				Start	End																		
Item	Encroachments			38.390848 °	38.391880 °																		
DWR ID	DWR_RD0999_05_f_2012_97																						
Action/Comments																							
Tree or limb Inspector Comments: Young trees on landside slope.

Looking west at newly planted tree on landside slope.

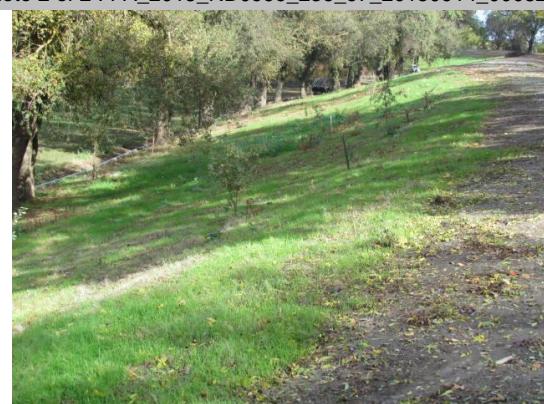
Photo 2 of 2 : FA_2015_RD0999_236_97_20150914_00082.jpg

Looking northwest at newly planted trees on landside slope.

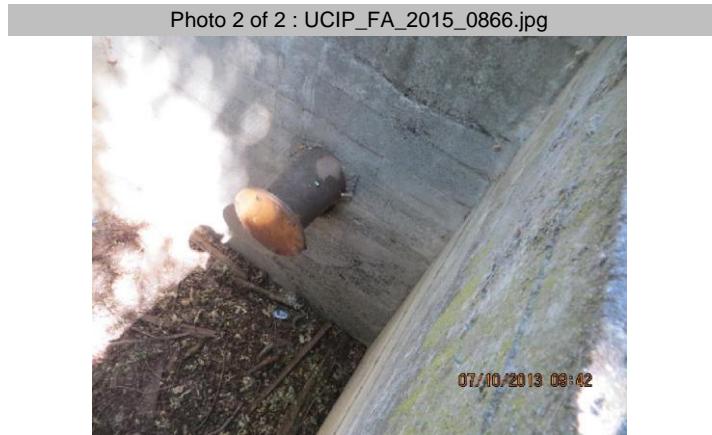
LM Start	6.47	Rating **	M	Issue No.	227 (cont)									
LM End	6.47	Issue Type +	En	Location *	LS									
Category	Supplemental			GPS Latitude/Longitude										
				Start	End									
Item	DWR UCIP Field Study			38.391723 °	38.391723 °									
				-121.539442 °	-121.539442 °									
DWR ID														
Action/Comments														
Inspector Comments: FS_ID:15604 DS_ID:22860 EP_NO: N/A FS_HLM: 6.57 Repair Type: Non-Urgent Crossing Status: Found UCIP Comments: Pipe abandoned and should be done so properly. FIELD_STRUCT_DESC: "Abandoned* 14-inch pipe through the levee 7.2 feet below the crown. Open 9'X14' concrete pump pit on waterward slope. Pipe has steel plate bolted over WS end . Originally included in the 1966 O&M manual. FS Date: 07/10/2013

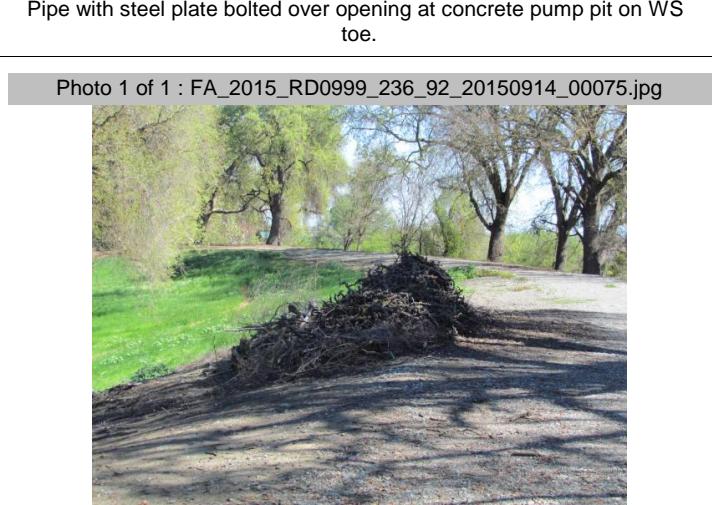
LM Start	6.48	Rating **	M	Issue No.	92									
LM End	6.48	Issue Type +	Ma	Location *	LS									
Category	Earthen Levee			GPS Latitude/Longitude										
				Start	End									
Item	Encroachments			38.391776 °	38.391776 °									
				-121.539295 °	-121.539295 °									
DWR ID	DWR_RD0999_05_s_2012_92													
Action/Comments														
Prunings

Looking east prunings on landward slope.

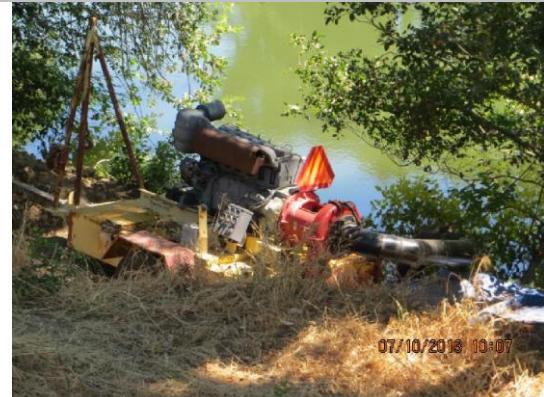
Photo 1 of 2 : UCIP_FA_2015_1375.jpg

LM Start	6.56	Rating **	M	Issue No.	228																			
LM End	6.56	Issue Type +	En	Location *	LS																			
Category				GPS Latitude/Longitude																				
				Start	End																			
Item				38.392788 °	38.392788 °																			
				-121.539047 °	-121.539047 °																			
DWR ID																								
Action/Comments																								
Inspector Comments: FS_ID:16342 DS_ID:23988 EP_NO: N/A FS_HLM: 6.659 Repair Type: Non-Urgent Crossing Status: Found UCIP Comments: Need to determine Permit No. for this crossing. FIELD_STRUCT_DESC: 8-inch aluminum irrigation pipe over the crown-pipe blocks crown when in use. Portable pump on WS toe. FS Date: 07/10/2013

Portable pump on WS toe.

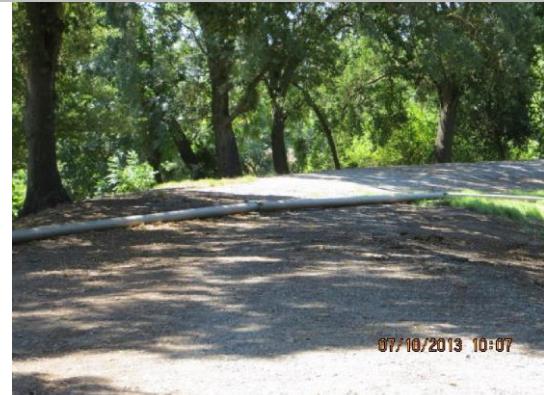
Photo 2 of 2 : UCIP_FA_2015_1376.jpg

Pipe at crossing over crown.

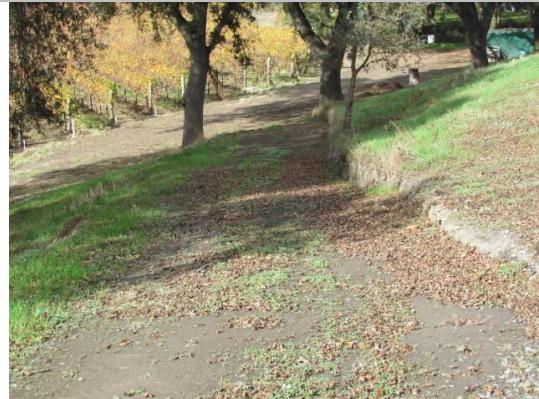
Photo 1 of 1 : FA_2015_RD0999_236_132_20150914_00093.jpg

LM Start	6.61	Rating **	M	Issue No.	132				
LM End	6.61	Issue Type +	En	Location *	LS				
Category	Earthen Levee			GPS Latitude/Longitude					
				Start	End				
Item	Encroachments			38.393578 °	38.393578 °				
				-121.539295 °	-121.539295 °				
DWR ID	DWR_RD0999_05_f_2012_132								
Action/Comments									
Ramp	Inspector Comments: Landowner installed ramp on landside slope without permit.

Looking east at unauthorized ramp on landside slope.

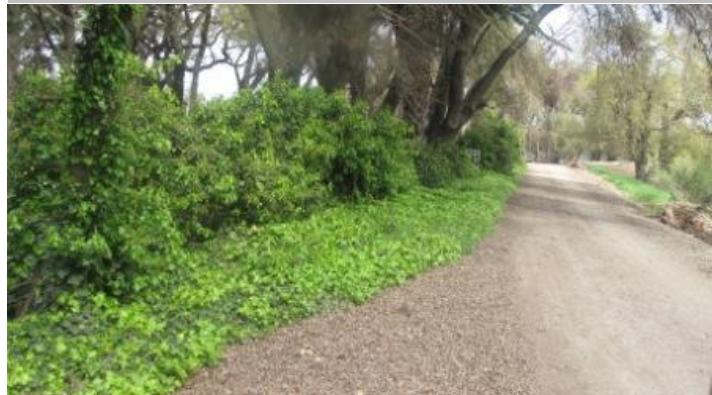
Photo 1 of 1 : FA_2015_RD0999_236_93_20150914_00076.jpg

LM Start	6.68	Rating **	U	Issue No.	93				
LM End	6.71	Issue Type +	En	Location *	LS				
Category	Earthen Levee			GPS Latitude/Longitude					
				Start	End				
Item	Vegetation			38.394491 °	38.394991 °				
				-121.539427 °	-121.539333 °				
DWR ID	DWR_RD0999_05_s_2012_93								
Action/Comments									
Landscaping	Inspector Comments: Overgrown landscape on landside slope and toe.

Looking north at overgrown landscape on landside slope and toe.

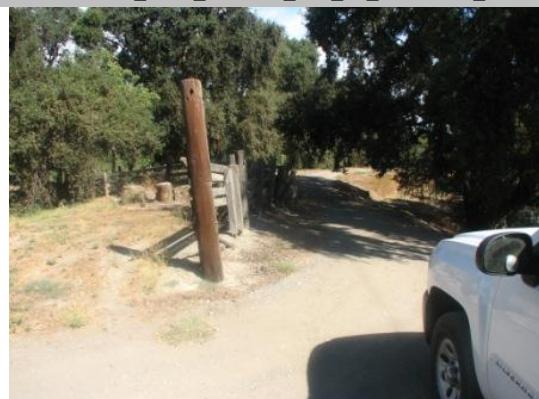
Photo 1 of 4 : FA_2015_RD0999_236_96_20150914_00077.jpg

LM Start	6.73	Rating **	M	Issue No.	96				
LM End	6.73	Issue Type +	Ma	Location *	LS				
Category	Earthen Levee			GPS Latitude/Longitude					
				Start	End				
Item	Encroachments			38.395234 °	38.395234 °				
				-121.539323 °	-121.539323 °				
DWR ID	DWR_RD0999_05_s_2012_96								
Action/Comments									
Material	Inspector Comments: Firewood and other material on landside shoulder.

Fence, firewood and material at landside shoulder.

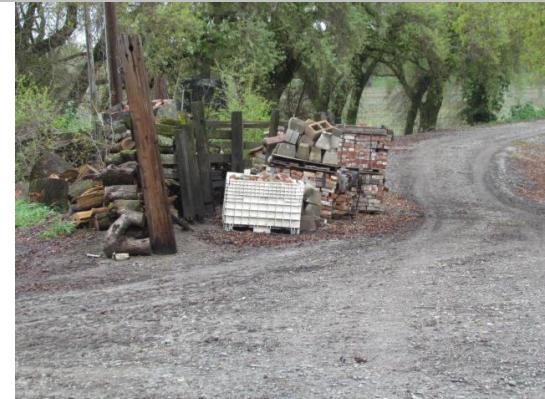
Photo 2 of 4 : FA_2015_RD0999_236_96_20150914_00078.jpg

Looking northeast at firewood and other material on landside shoulder.
(Spring 2012)

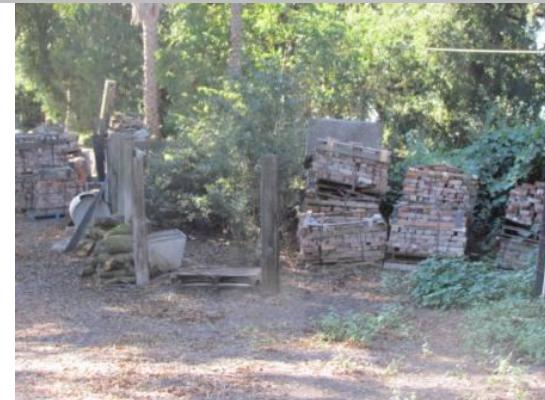
Photo 3 of 4 : FA_2015_RD0999_236_96_20150914_00079.jpg

Looking south at firewood and other material on landside shoulder and crown.

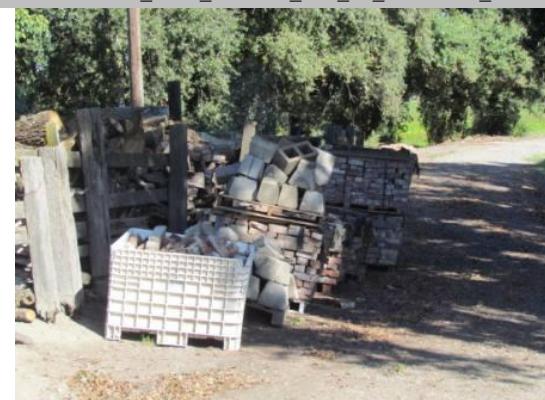
Photo 4 of 4 : FA_2015_RD0999_236_96_20150914_00080.jpg

Looking north at firewood and other material on landside shoulder and crown.

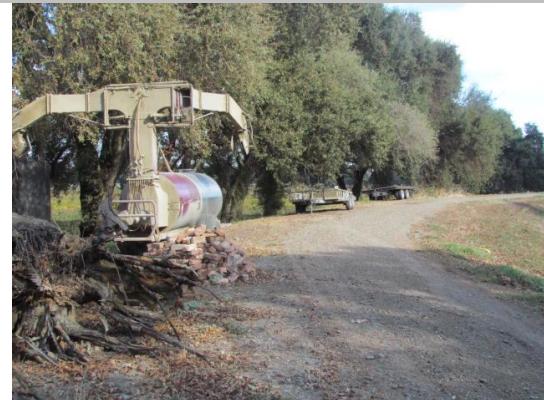
Photo 1 of 3 : FA_2015_RD0999_236_156_20150914_00107.jpg

LM Start	6.79	Rating **	M	Issue No.	156													
LM End	6.83	Issue Type +	En	Location *	LS													
Category	Earthen Levee			GPS Latitude/Longitude														
				Start	End													
Item	Encroachments			38.395945 °	38.396307 °													
				-121.538859 °	-121.538177 °													
DWR ID	DWR_RD0999_05_f_2013_156																	
Action/Comments																		
Equipment Inspector Comments: Landowner is storing farm equipment on landward shoulder.

Looking north at farm equipment on landward shoulder (Fall 2014)

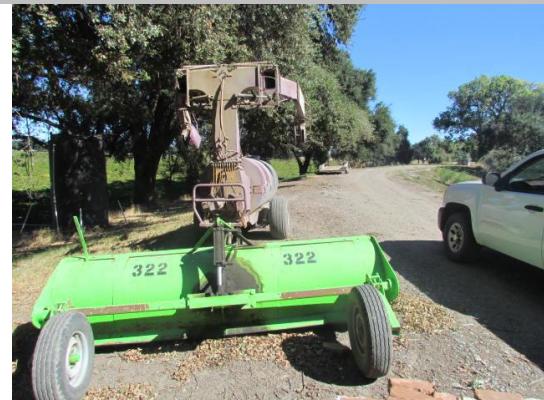
Photo 2 of 3 : FA_2015_RD0999_236_156_20150914_00108.jpg

Looking north at farm equipment on landward shoulder.

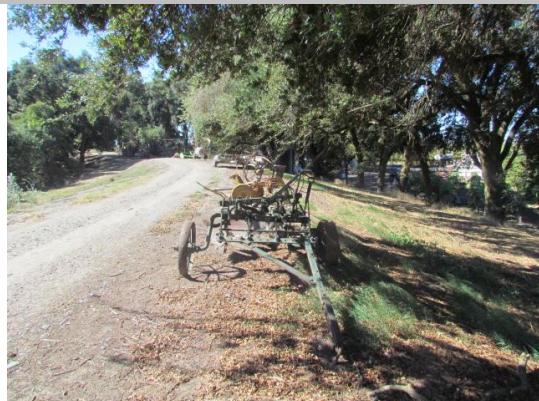
Photo 3 of 3 : FA_2015_RD0999_236_156_20150914_00109.jpg

Looking south at farm equipment on landward shoulder.

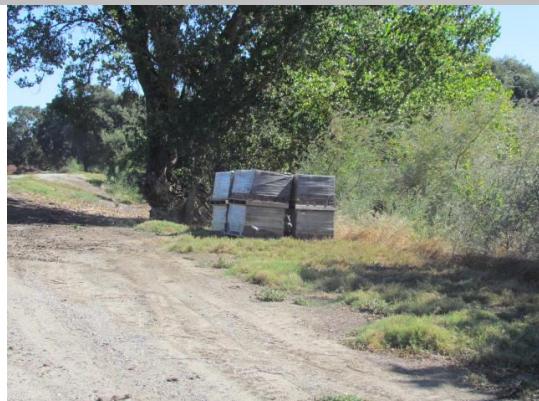
Photo 1 of 1 : FA_2015_RD0999_236_157_20150914_00110.jpg

LM Start	6.80	Rating **	M	Issue No.	157							
LM End	6.80	Issue Type +	En	Location *	WS							
Category	Earthen Levee			GPS Latitude/Longitude								
				Start	End							
Item	Encroachments			38.396099 °	38.396099 °							
				-121.538585 °	-121.538585 °							
DWR ID	DWR_RD0999_05_f_2013_157											
Action/Comments												
Material												
Inspector Comments: Landowner is storing pallets of bricks on waterward shoulder.

Looking northeast at pallets of bricks stored on waterward shoulder.

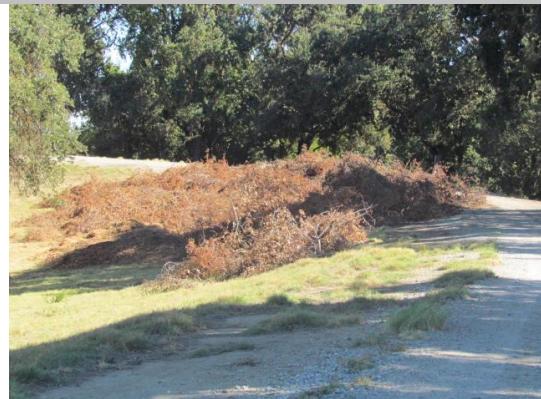
Photo 1 of 1 : FA_2015_RD0999_236_142_20150914_00098.jpg

LM Start	6.95	Rating **	A/W	Issue No.	142										
LM End	6.95	Issue Type +	Ma	Location *	LS										
Category	Earthen Levee			GPS Latitude/Longitude											
				Start	End										
Item	Encroachments			38.396958 °	38.396958 °										
				-121.536148 °	-121.536148 °										
DWR ID	DWR_RD0999_05_s_2013_142														
Action/Comments															
Prunings Inspector Comments: Large pruning pile on landward shoulder and slope.

Looking northeast at large prunings on landward slope.

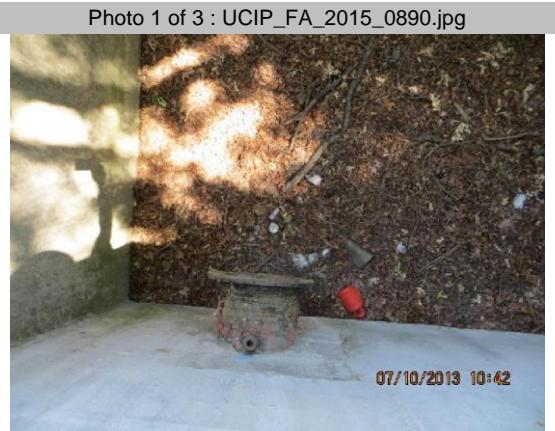
LM Start	7.51	Rating **	U	Issue No.	229							
LM End	7.51	Issue Type +	En	Location *	LS							
Category	Supplemental			GPS Latitude/Longitude								
				Start	End							
Item	DWR UCIP Field Study			38.403744 °	38.403744 °							
				-121.540714 °	-121.540714 °							
DWR ID												
Action/Comments												
Inspector Comments: FS_ID:15617 DS_ID:22863 EP_NO: N/A FS_HLM: 7.63 Repair Type: Urgent Crossing Status: Found UCIP Comments: Pipe abandoned and open on both ends. Concrete pump pit foundation undermined at WS toe. Pipe should be abandoned properly FIELD_STRUCT_DESC: *Abandoned* 14-inch steel irrigation pipe through the levee 4.8 feet below the crown. Abandoned 9'X14' concrete pump pit on waterward slope. Pipe open at both ends. Originally included in the 1966 O&M manual. FS Date: 07/10/2013

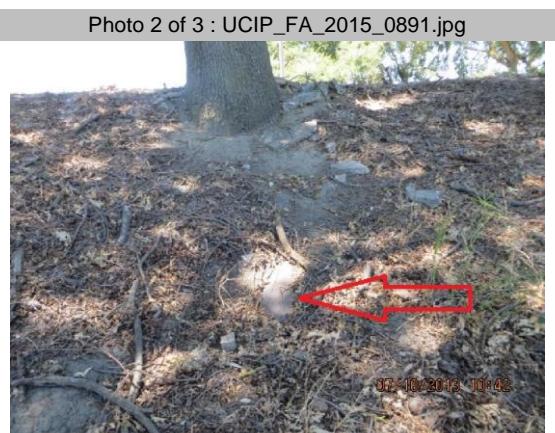
LM Start	7.51	Rating **	U	Issue No.	229 (cont)	
LM End	7.51	Issue Type +	En	Location *	LS

Pipe visible on WS slope.

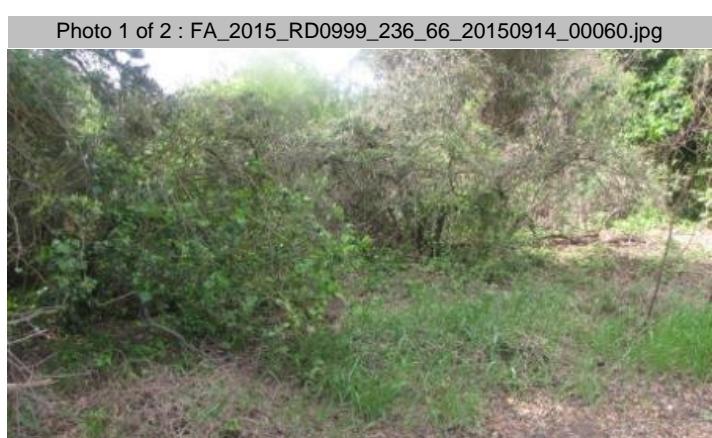
LM Start	7.54	Rating **	U	Issue No.	66									
LM End	7.58	Issue Type +	En	Location *	LS									
Category	Earthen Levee			GPS Latitude/Longitude										
				Start	End									
Item	Vegetation			38.403895 °	38.404145 °									
				-121.541113 °	-121.541835 °									
DWR ID	DWR_RD0999_05_s_2012_66													
Action/Comments														
Landscaping

Looking east at overgrown landscape on landside slope.

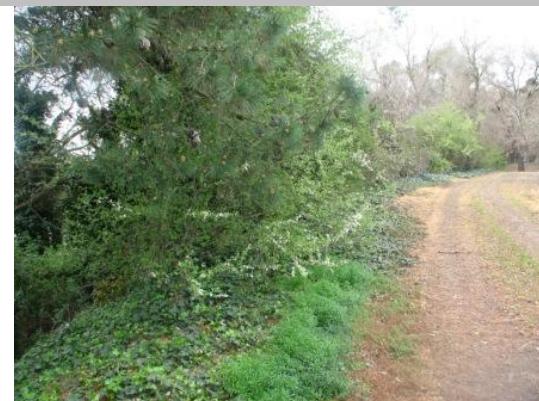
Photo 1 of 2 : FA_2015_RD0999_236_66_20150914_00060.jpg

Landscaping on landside slope blocking view of slope.

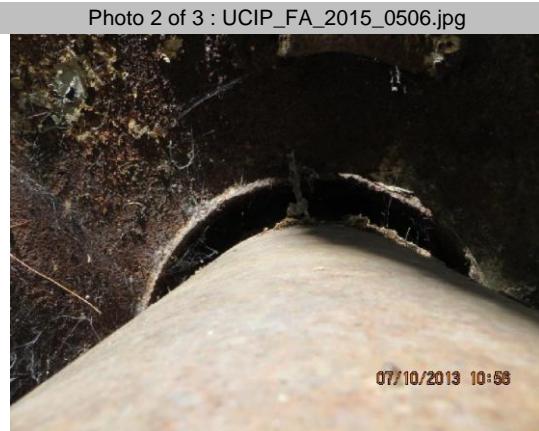
LM Start	7.57	Rating **	M	Issue No.	230 (cont)									
LM End	7.57	Issue Type +	En	Location *	WS									
Category	Supplemental			GPS Latitude/Longitude										
				Start	End									
Item	DWR UCIP Field Study			38.403993 °	38.403993 °									
				-121.541626 °	-121.541626 °									
DWR ID														
Action/Comments														
Inspector Comments: FS_ID:15624 DS_ID:22864 EP_NO: N/A FS_HLM: 7.68 Repair Type: Non-Urgent Crossing Status: Found UCIP Comments: Annular space needs to be grouted between the 12 and 14-inch pipes. FIELD_STRUCT_DESC: 14-inch steel irrigation pipe through the levee 7.0 feet below the crown. 12-inch pipe sleeved through 14-inch pipe. Annular space not grouted. 36-inch concrete standpipe on LS toe. Originally included in the 1966 O&M manual. FS Date: 07/10/2013

Notice: No grout between sleeved pipes.

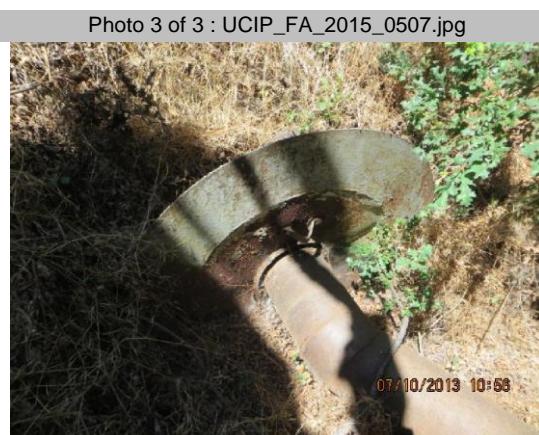
12-inch pipe sleeved through 14-inch pipe at WS slope. Erosion around pipe on levee slopes-both sides of levee.

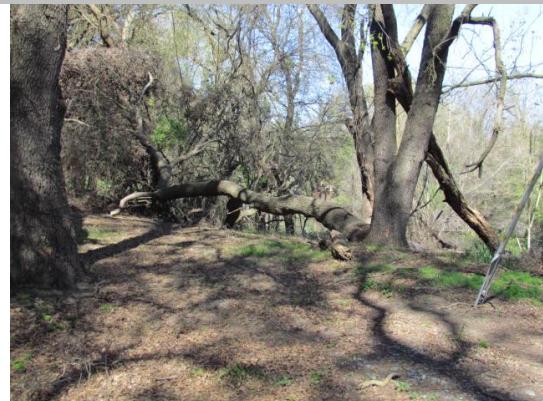
Photo 1 of 1 : FA_2015_RD0999_236_193_20150914_00118.jpg

LM Start	7.58	Rating **	A/W	Issue No.	193										
LM End	7.58	Issue Type +	En	Location *	WS										
Category	Earthen Levee			GPS Latitude/Longitude											
				Start	End										
Item	Encroachments			38.404135 °	38.404135 °										
				-121.541878 °	-121.541878 °										
DWR ID	DWR_RD0999_05_s_2014_193														
Action/Comments															
Tree or limb Inspector Comments: Downed tree on waterward shoulder.

Looking east at downed tree on waterward shoulder.

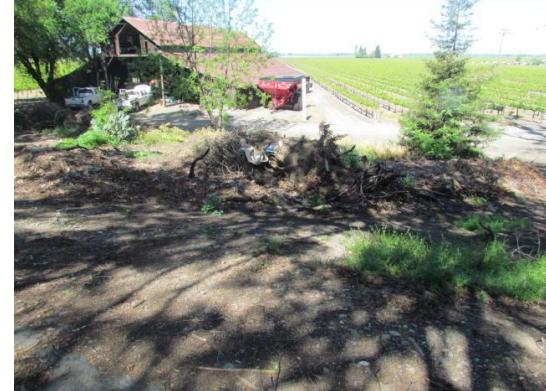
Photo 1 of 1 : FA_2015_RD0999_236_185_20150914_00113.jpg

LM Start	8.03	Rating **	M	Issue No.	185												
LM End	8.03	Issue Type +	Ma	Location *	LS												
Category	Earthen Levee			GPS Latitude/Longitude													
				Start	End												
Item	Encroachments			38.409324 °	38.409324 °												
DWR ID	DWR_RD0999_05_s_2015_185			-121.541223 °	-121.541223 °												
Action/Comments																	
Prunings Inspector Comments: Garbage within prunings piles.

Looking west at pruning piles on landward slope. (Spring 2015)

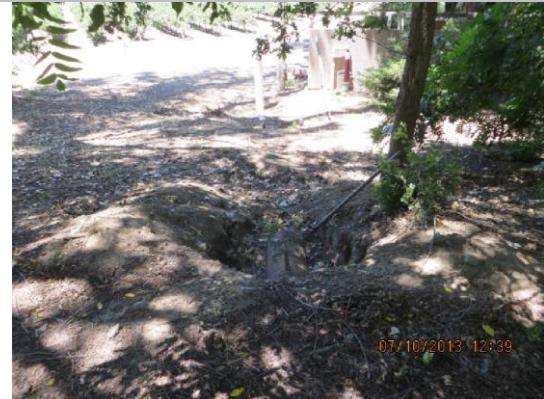
Photo 1 of 3 : UCIP_FA_2015_1015.jpg

LM Start	8.04	Rating **	M	Issue No.	233							
LM End	8.04	Issue Type +	En	Location *	LS							
Category	Supplemental			GPS Latitude/Longitude								
				Start	End							
Item	DWR UCIP Field Study			38.409421 °	38.409421 °							
				-121.541007 °	-121.541007 °							
DWR ID												
Action/Comments												
Inspector Comments: FS_ID:15683 DS_ID:22881 EP_NO: 13463 FS_HLM: 8.173 Repair Type: Non-Urgent Crossing Status: Found UCIP Comments: Pipe exposed in excavation on LS shoulder at what may be a leak. FIELD_STRUCT_DESC: 12-inch pipe through the levee 2.5-feet below the crown. Pump on pile structure with walkway on WS toe. 12-inch PVC standpipe on LS toe next to filter plant and shed. (Permit No. 13463, 1982). 1.5-inch PVC electrical conduit at same location. This pipe replaced an existing 8-inch pipe that was grouted in place. FS Date: 07/10/2013

Pipe visible on LS shoulder with siphon breaker.

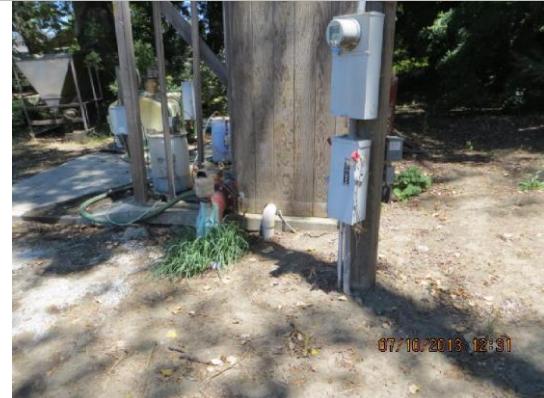
Photo 2 of 3 : UCIP_FA_2015_1016.jpg

Air vent and butterfly valve at filter plant/shed. Meter on JP with electrical controls.

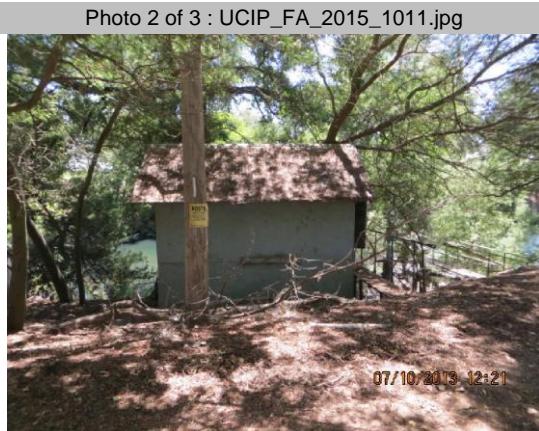
LM Start	8.05	Rating **	M	Issue No.	234 (cont)									
LM End	8.05	Issue Type +	En	Location *	LS									
Category	Supplemental			GPS Latitude/Longitude										
				Start	End									
Item	DWR UCIP Field Study			38.409440 °	38.409440 °									
				-121.540928 °	-121.540928 °									
DWR ID														
Action/Comments														
Inspector Comments: FS_ID:15663 DS_ID:22868 EP_NO: N/A FS_HLM: 8.177 Repair Type: Non-Urgent Crossing Status: Found UCIP Comments: Pipe abandoned and should be done so properly. FIELD_STRUCT_DESC: *Abandoned* 14-inch pipe through levee 14.4 feet below crown. Gate valve at pump in Concrete pit under pumphouse on WS slope. Originally included in the 1966 O&M manual. FS Date: 07/10/2013

Concrete pumphouse on WS slope.

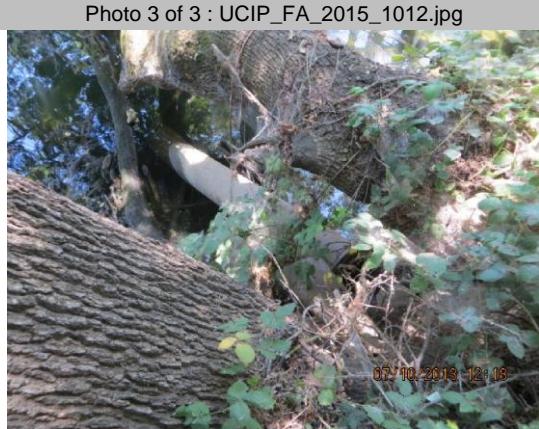
14-inch pipe visible at WS toe below pumphouse.

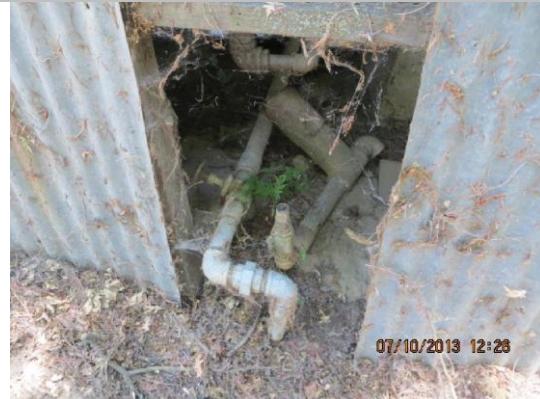
Photo 1 of 2 : UCIP_FA_2015_1013.jpg

Pipe visible inside pumphouse on WS slope.

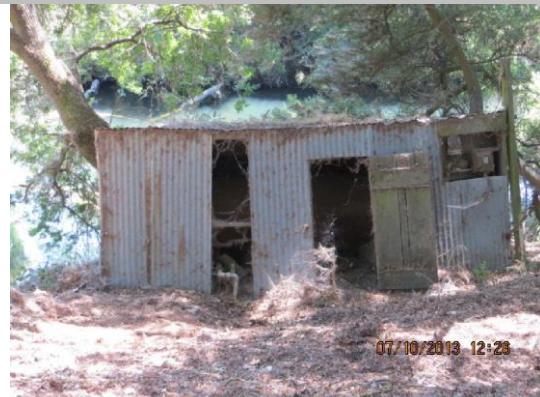
Photo 2 of 2 : UCIP_FA_2015_1014.jpg

Pipe visible inside pumphouse on WS slope.

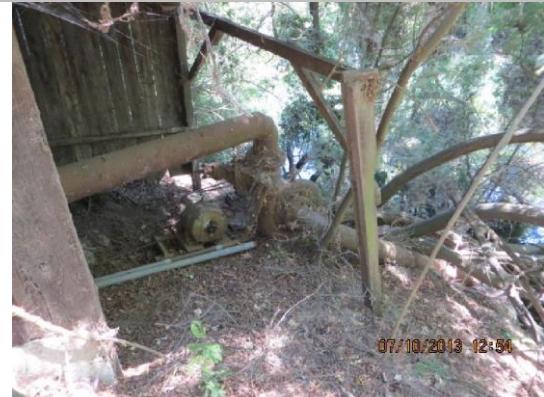
Photo 1 of 3 : UCIP_FA_2015_1018.jpg

LM Start	8.10	Rating **	M	Issue No.	236									
LM End	8.10	Issue Type +	En	Location *	WS									
Category				GPS Latitude/Longitude										
				Start	End									
Item				DWR UCIP Field Study	38.409749 °	38.409749 °								
					-121.540079 °	-121.540079 °								
DWR ID														
Action/Comments														
Inspector Comments: FS_ID:15685 DS_ID:22871 EP_NO: 4851 FS_HLM: 8.23 Repair Type: Non-Urgent Crossing Status: Found UCIP Comments: Pipe appears to be abandoned and should be done so properly. FIELD_STRUCT_DESC: 8-inch pipe through levee 6.2 feet below crown. Gate valve in pump house on the waterward slope, service pole on both slopes (Permit No 4851, 1965). Originally included in the 1966 O&M manual. FS Date: 07/10/2013

Pump and gatevalve in pumphouse on WS toe.

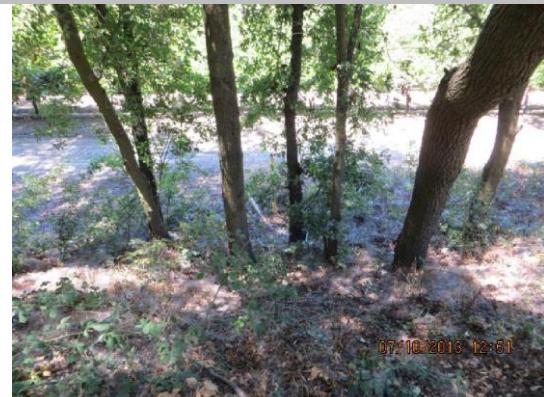
Photo 2 of 3 : UCIP_FA_2015_1019.jpg

Possible location for original outlet on LS of Netherlands road.

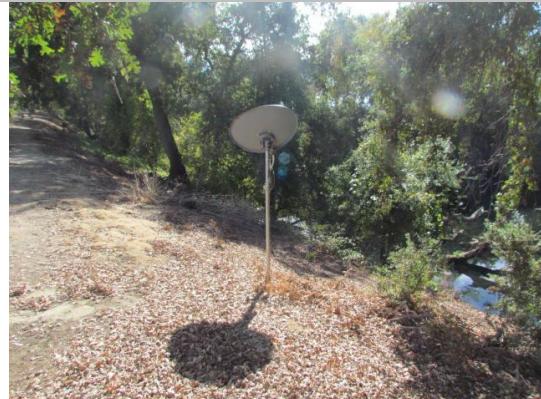
Photo 1 of 3 : FA_2015_RD0999_236_207_20150914_00125.jpg

LM Start	8.28	Rating **	M	Issue No.	207				
LM End	8.28	Issue Type +	En	Location *	LS				
Category	Earthen Levee		GPS Latitude/Longitude						
			Start	End					
Item	Encroachments		38.409389 °	38.409389 °					
			-121.536881 °	-121.536881 °					
DWR ID	DWR_RD0999_05_f_2014_207								
Action/Comments									
Pipe									
Inspector Comments: Electrical conduct buried across levee crown. Conduct connects to satellite dish on waterward shoulder.

Looking south at satellite dish on waterward shoulder.

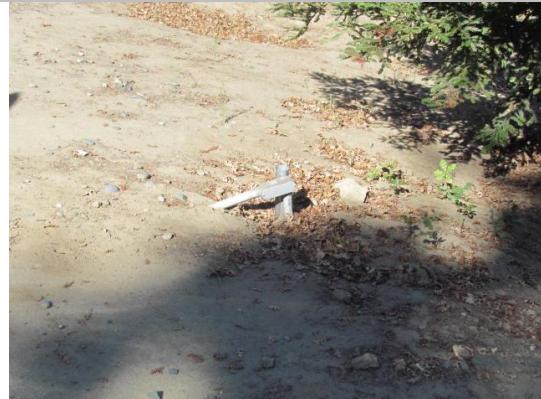
Photo 2 of 3 : FA_2015_RD0999_236_207_20150914_00126.jpg

Looking west at electrical box on landward shoulder.

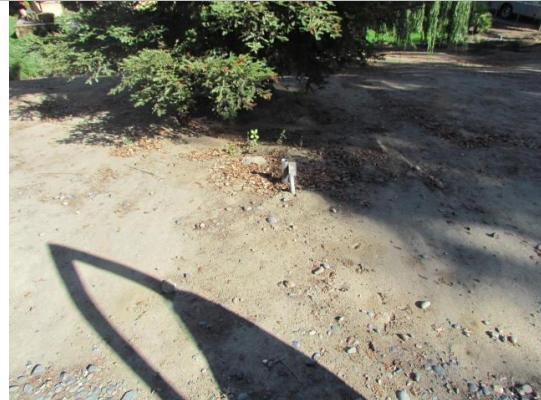
Photo 3 of 3 : FA_2015_RD0999_236_207_20150914_00127.jpg

Looking northeast at electrical box on landward shoulder.

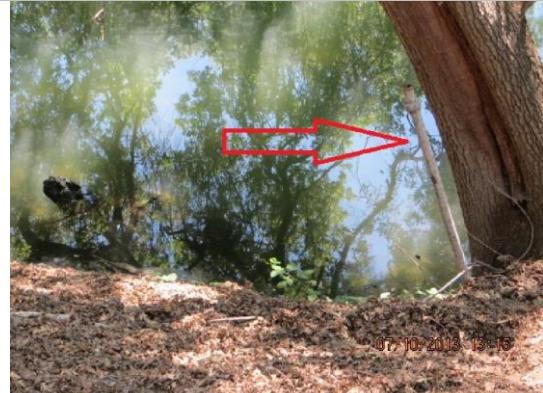
Photo 1 of 3 : UCIP_FA_2015_1021.jpg

LM Start	8.29	Rating **	M	Issue No.	237																		
LM End	8.29	Issue Type +	En	Location *	LS																		
Category	Supplemental			GPS Latitude/Longitude																			
				Start	End																		
Item	DWR UCIP Field Study			38.409264 °	38.409264 °																		
DWR ID																							
Action/Comments																							
Inspector Comments: FS_ID:15686 DS_ID:22872 EP_NO: N/A FS_HLM: 8.43 Repair Type: Non-Urgent Crossing Status: Indicator Found UCIP Comments: Type of pipe abandonment needs to be verified. FIELD_STRUCT_DESC: *Abandoned* 8-inch pipe through levee 11.7 feet below crown, no control valves. 1.5-inch galvanized iron electrical conduit found on WS slope at oak tree. 8-inch Pipe debris visible on WS slope. Originally included in the 1966 O&M manual. FS Date: 07/10/2013

1.5-inch electrical conduit visible on WS slope next to oak.

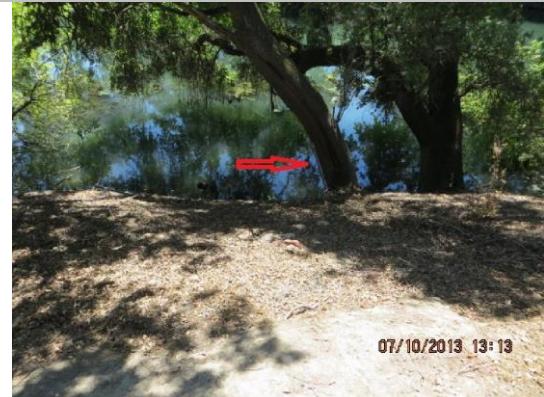
Photo 2 of 3 : UCIP_FA_2015_1022.jpg

1.5-inch electrical conduit visible on WS slope next to oak.

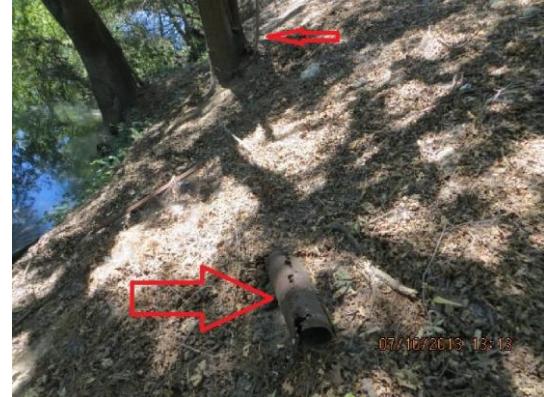
Photo 3 of 3 : UCIP_FA_2015_1026.jpg

8-inch pipe debris with 1.5-inch electrical conduit visible in background on WS slope.

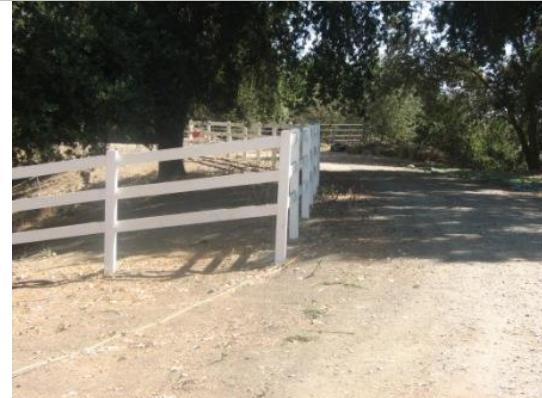
Photo 1 of 1 : FA_2015_RD0999_236_101_20150914_00083.jpg

LM Start	8.39	Rating **	M	Issue No.	101																		
LM End	8.43	Issue Type +	En	Location *	LS																		
Category	Earthen Levee			GPS Latitude/Longitude																			
				Start	End																		
Item	Encroachments			38.408586 °	38.408748 °																		
DWR ID	DWR_RD0999_05_s_2012_101																						
Action/Comments																							
Fence Inspector Comments: Fence installed without CVFPB permit in 2008. Fence extends from landside toe to landside shoulder.

New installed unauthorized fence at landside slope and shoulder.

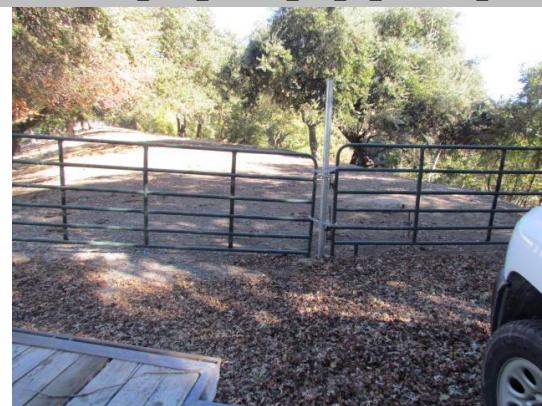
Photo 1 of 3 : FA_2015_RD0999_236_81_20151106_00168.jpg

LM Start	8.42	Rating **	U	Issue No.	81																		
LM End	8.42	Issue Type +	En	Location *	CR																		
Category	Earthen Levee			GPS Latitude/Longitude																			
				Start	End																		
Item	Encroachments			38.408612 °	38.408612 °																		
DWR ID	DWR_RD0999_05_f_2015_81																						
Action/Comments																							
Fence Inspector Comments: Landowner blocking access to levee with fence across levee and trailer in front of gate.

Looking east at fence and gate across levee crown.

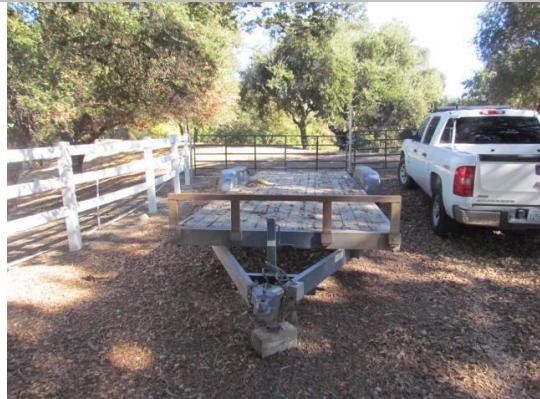
Photo 2 of 3 : FA_2015_RD0999_236_81_20151106_00169.jpg

Looking east at trailer blocking access to the levee.

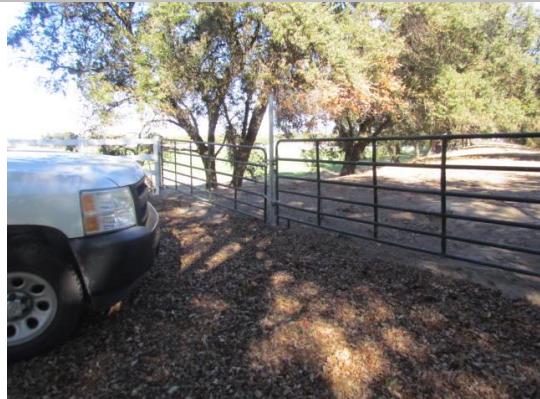
Photo 3 of 3 : FA_2015_RD0999_236_81_20151106_00170.jpg

Looking north at fence and gate across levee crown.

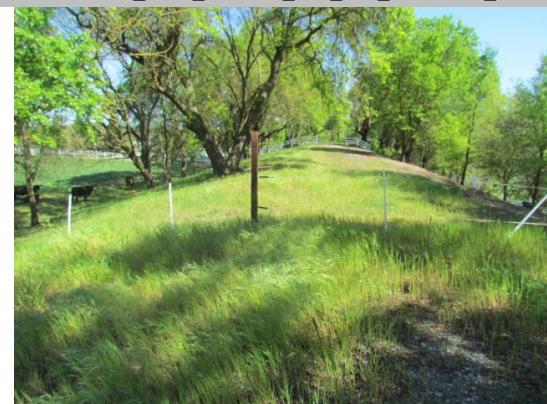
LM Start	8.50	Rating **	M	Issue No.	187		Photo 1 of 1 : FA_2015_RD0999_236_187_20150914_00114.jpg											
LM End	8.50	Issue Type +	En	Location *	CR													
Category	Earthen Levee			GPS Latitude/Longitude														
				Start	End													
Item	Encroachments			38.409395 °	38.409395 °													
				-121.533593 °	-121.533593 °													
DWR ID	DWR_RD0999_05_s_2015_187																	
Action/Comments																		
Fence Inspector Comments: Landowner installed a electrical fence across levee crown.

Looking east at new electrical fence across levee crown and landward slope. (Spring 2015)

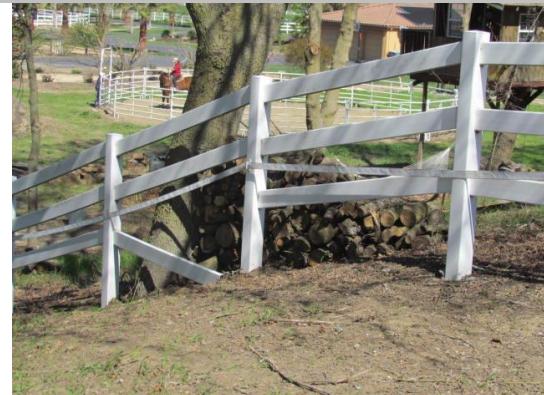
Photo 1 of 1 : FA_2015_RD0999_236_195_20150914_00119.jpg

LM Start	8.54	Rating **	M	Issue No.	195										
LM End	8.54	Issue Type +	En	Location *	LS										
Category	Earthen Levee			GPS Latitude/Longitude											
				Start	End										
Item	Encroachments			38.409880 °	38.409880 °										
				-121.533078 °	-121.533078 °										
DWR ID	DWR_RD0999_05_s_2014_195														
Action/Comments															
Firewood															
Inspector Comments: Firewood stock piled on landside slope.

Looking northeast at firewood on landward slope.

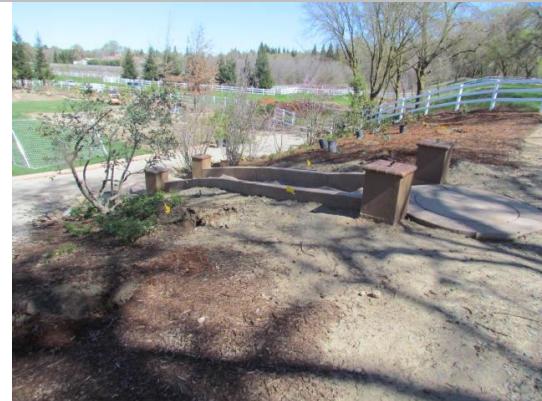
Photo 1 of 2 : FA_2015_RD0999_236_196_20150914_00120.jpg

LM Start	8.58	Rating **	M	Issue No.	196										
LM End	8.58	Issue Type +	En	Location *	LS										
Category	Earthen Levee			GPS Latitude/Longitude											
				Start	End										
Item	Encroachments			38.410279 °	38.410279 °										
				-121.532414 °	-121.532414 °										
DWR ID	DWR_RD0999_05_s_2014_196														
Action/Comments															
Stairway Inspector Comments: Landowner installed concrete stairs and sprinkler and plantings on landside slope without CVFPB permit.

Looking east at concrete stairs, sprinklers and plantings on landward slope.
